ENGINEERING STUDIES FOR A CONTRACT FOR FIELD
INVESTIGATION OF HIGH WATER DAMAGE
IN OSWEGO COUNTY, NEW YORK

Contract Number
DACW 23-75-C-0033

St. Lawrence-Eastern Ontario Commission
317 Washington Street
Watertown, New York 13601

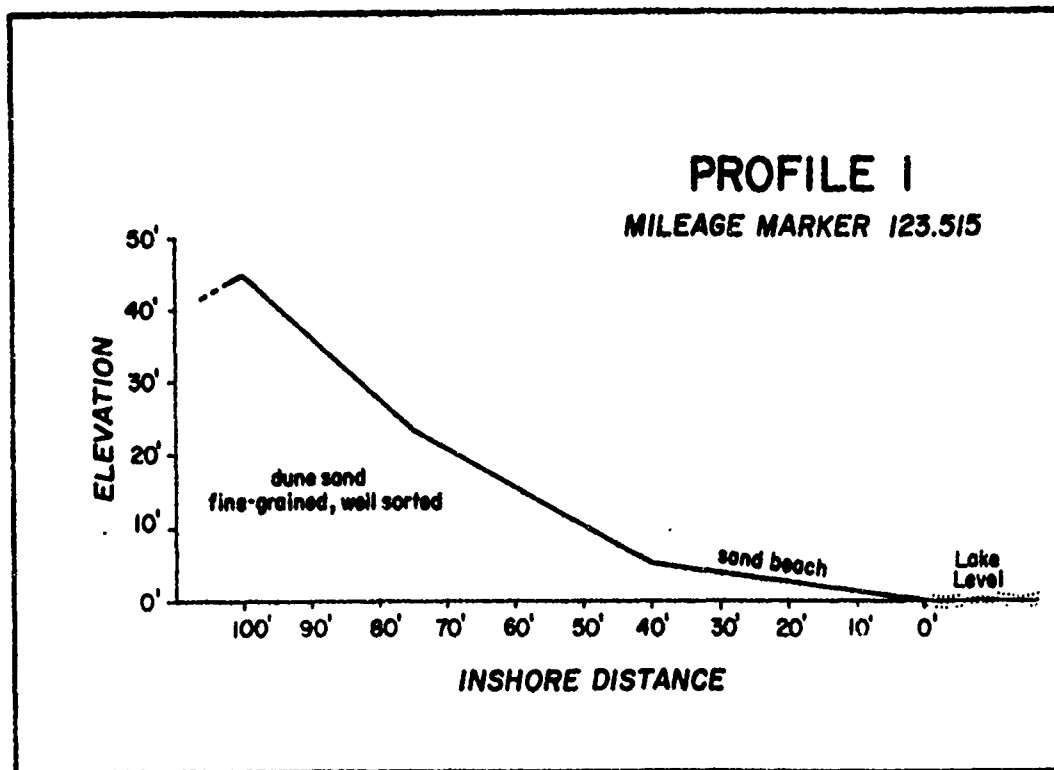
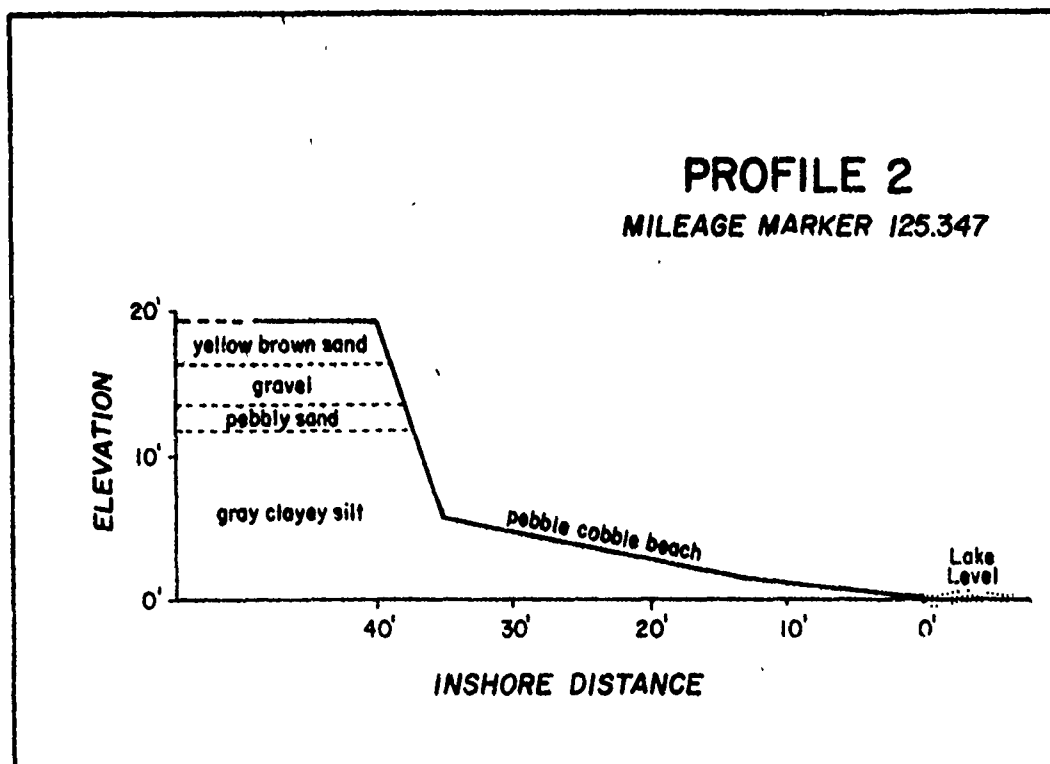
Figure 2a. Shore Profiles -- Oswego County, New York.

The bluff is partially protected by a 40 foot wide beach as well as by a sand bar that lies 80-100 feet offshore. Both the beach and the inshore sediments consist of well sorted, fine grained sand.

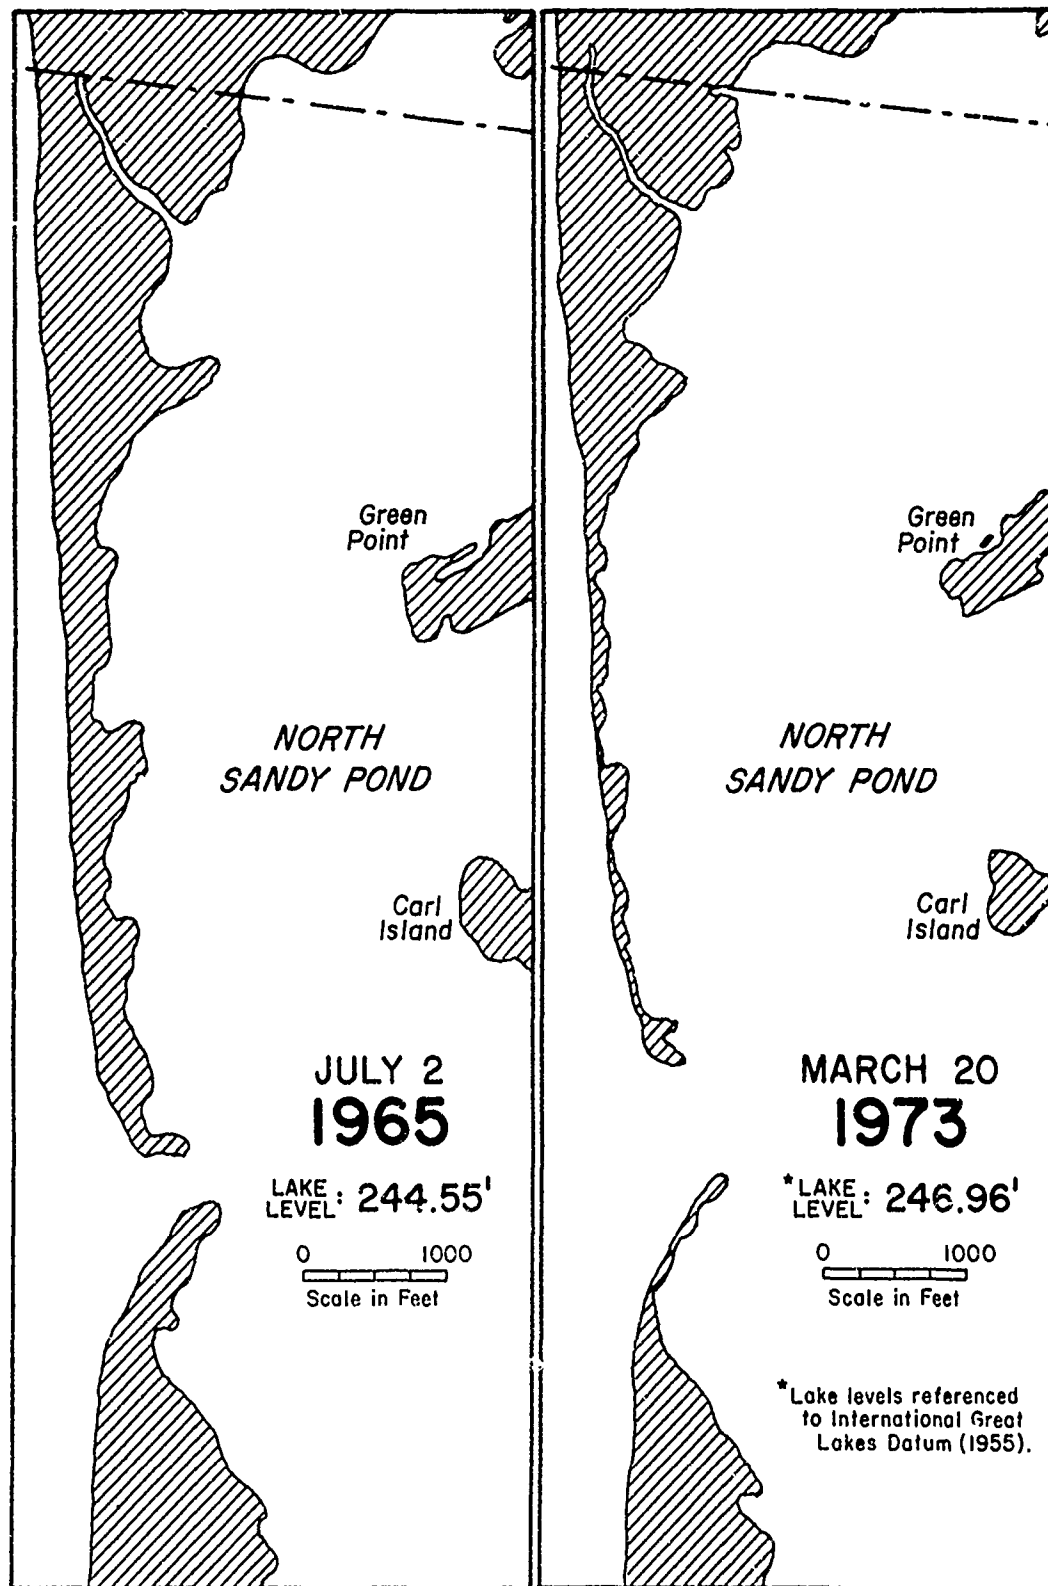
FIGURE 3. North Sandy Pond Beach Configuration: 1965 and 1973

Significant damage to dune areas has occurred as is indicated on Figure 4. The loss of these dunes has a negative impact on the marsh and wetland inland which are normally shielded from storms by the dunes. The North Pond area has undergone dramatic change as have other dunal areas to the north. These changes are in the form of erosion and deposition of erodible material; changes in channel locations; increase in exposure to storm wave attack and destabilization of formerly stabilized sand dunes.
